# HOME FORWARD CIVIC STATION PROJECT INFORMATION FOR WETLAND 8-STEP DECISION MAKING PROCESS

**Home Forward Civic Station Wetland 8-Step Decision Making Process**

# Wetland Delineation Report

# **Civic Station**

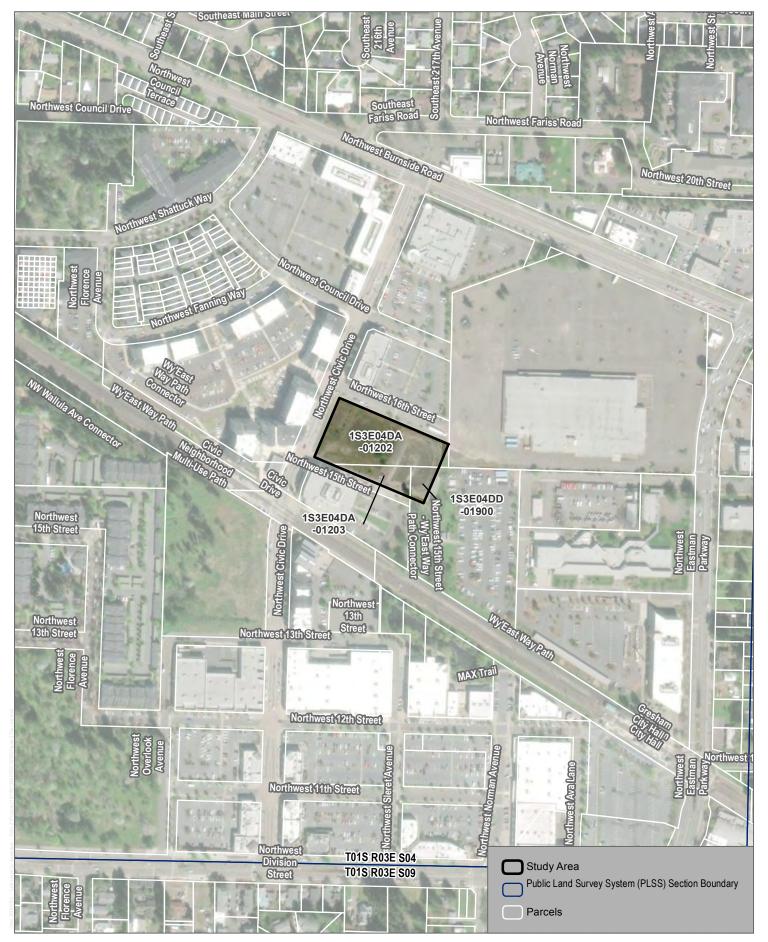
FIGURE 1
Project Vicinity

SOURCE: USGS 7.5- Minute Series Quadrangle, Camas Township 1S/ Range 3E/ Section 4/ Quarter Section SW

Dudek has been requested to conduct a wetland delineation at parcels located along NW Civic Drive between NW 15th Street and NW 16th Street in Gresham, Multnomah County, Oregon. The study area sits on 2.1 acres of vacant land (Figure 1, Project Vicinity; Figures 1–7 are provided in Appendix A). The study area is in Section 4DA of Township 1 South, Range 3 East, Willamette Meridian on Tax Lots 1202 and 1203 (owned by Metro), and Section 4DD, Township 1 South, Range 3 East, Willamette Meridian, Tax Lot 1900 (owned by the City of Gresham). The study area is bound to the north by NW 16th Street, to the southeast by City of Gresham equipment storage, to the south by NW 15th Street, and to the west by NW Civic Drive. The study area is shown in Figure 1, Project Vicinity, and Figure 2, Tax Lots.

The elevation on the study area ranges between approximately 300 and 310 feet above mean sea level. The study area sits in a suburban area surrounded by commercial buildings, civic offices, a light rail to the south, and suburban housing in the larger vicinity (Figures 1 and 2). The west side of the study area is mostly mowed grasses and forbs with gravel paths throughout. A gravel parking lot covers the east side of the study aera and is used as overflow parking for the Center for Advanced Learning, a charter high school located south from the study area across NW 15th Street.

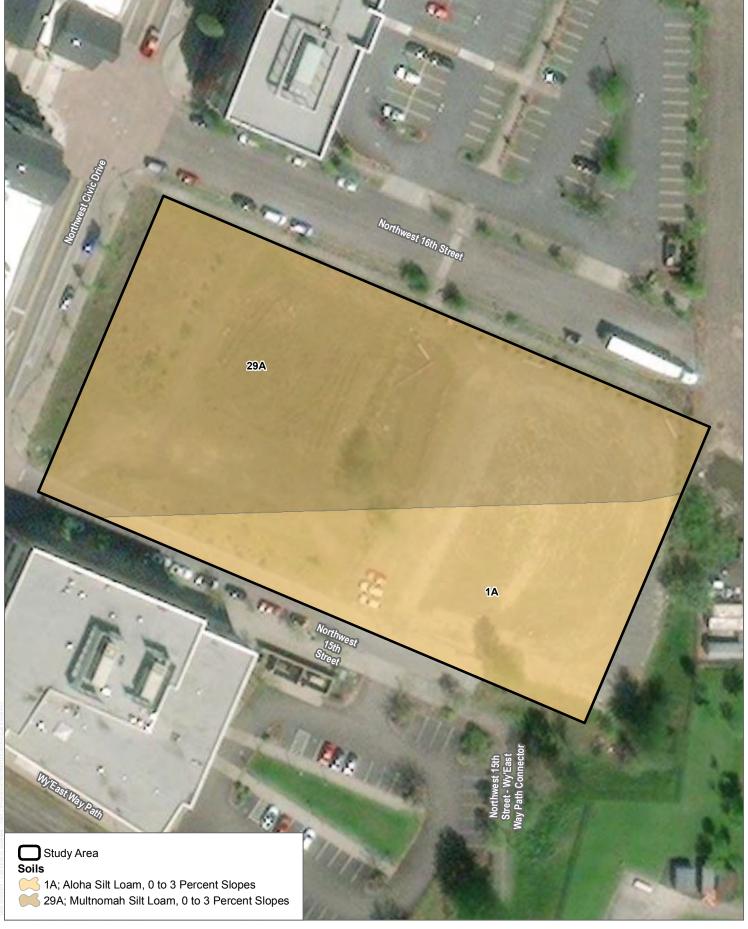
FIGURE 5 Soils

Two soil types are mapped within the study area: Aloha silt loam, 0% to 3% slopes, and Multnomah silt loam, 0% to 3% slopes (Figure 5, Soils). Neither soil type is listed as hydric. These soils have been largely replaced or otherwise altered by fill activities over the past 20–30 years.

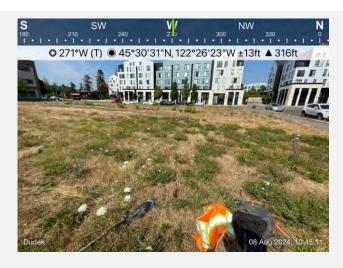
Photo 1. View facing west at WSP-TV-01. Taken August 8, 2024.

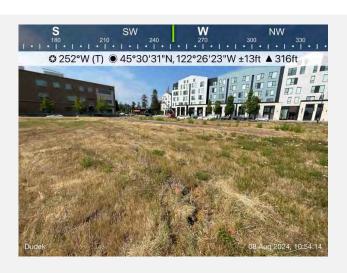
Photo 2. View facing west at WSP-TV-02. WET-B is at left.

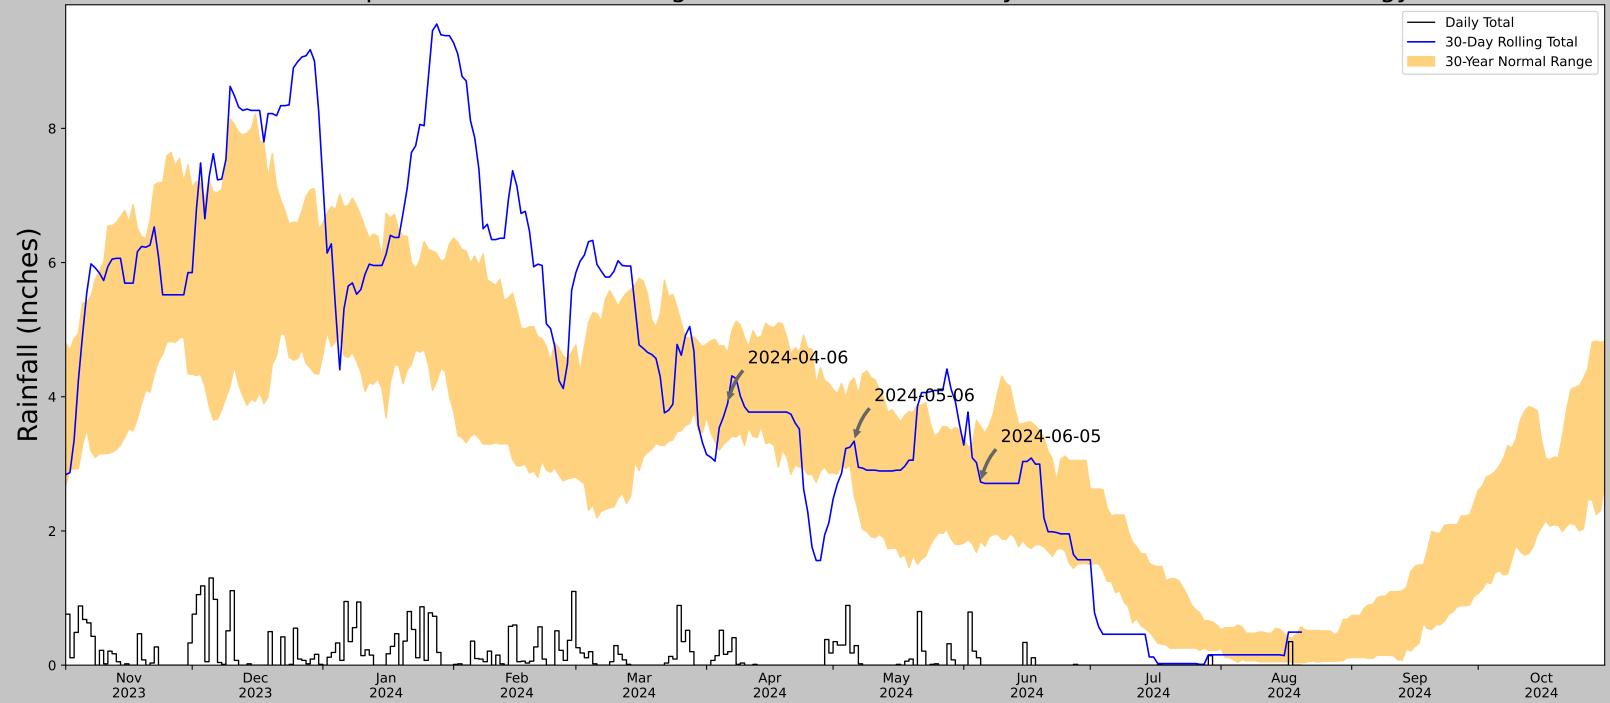
# Antecedent Precipitation vs Normal Range based on NOAA's Daily Global Historical Climatology Network

Coordinates	45.508578, -122.439792
Observation Date	2024-06-05
Elevation (ft)	309.455
Drought Index (PDSI)	Incipient drought
WebWIMP H <sub>2</sub> O Balance	Dry Season

30 Days Ending	30 <sup>th</sup> %ile (in)	70 <sup>th</sup> %ile (in)	Observed (in)	Wetness Condition	Condition Value	Month Weight	Product
2024-06-05	1.846063	3.557087	2.728347	Normal	2	3	6
2024-05-06	2.533465	4.279921	3.338583	Normal	2	2	4
2024-04-06	3.345276	4.655118	3.901575	Normal	2	1	2
Result							Normal Conditions - 12

Precipitation data were also collected using the USACE APT to determine if the site was within normal conditions for the 90 days prior to the three site visits (Appendix D). The results of the query are below in Table 3.

The APT shows normal conditions were present during both site visits. During the June 5, 2024, site visit, conditions were wet with saturation and standing water in the depressional areas. As the recent precipitation was above average, this leads to the conclusion that the wet conditions are unusual for this time of year. However, it may be representative of wet early growing season conditions. In August, secondary indicators of hydrology and evidence of hydric soil and hydrophytic vegetation were used to support determinations of wetlands.

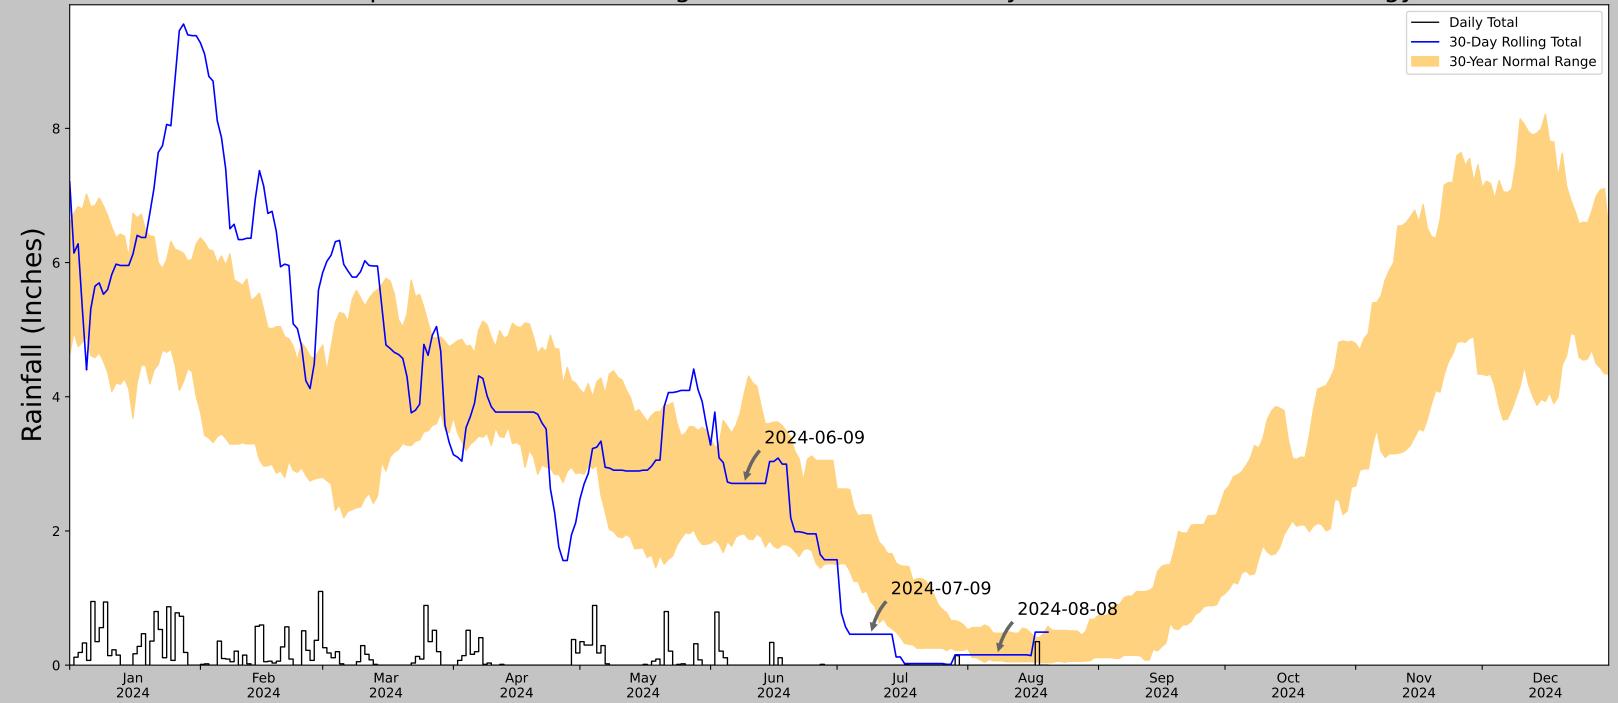
# Antecedent Precipitation vs Normal Range based on NOAA's Daily Global Historical Climatology Network

Coordinates	45.508578, -122.439792
Observation Date	2024-08-08
Elevation (ft)	309.455
Drought Index (PDSI)	Mild drought (2024-07)
WebWIMP H <sub>2</sub> O Balance	Dry Season

30 Days Ending	30 <sup>th</sup> %ile (in)	70 <sup>th</sup> %ile (in)	Observed (in)	Wetness Condition	Condition Value	Month Weight	Product
2024-08-08	0.064961	0.475591	0.153543	Normal	2	3	6
2024-07-09	0.94252	2.239764	0.46063	Dry	1	2	2
2024-06-09	1.955118	4.055906	2.708662	Normal	2	1	2
Result							Normal Conditions - 10
